## Assessment of SMC frames under different column removal scenarios

## Assessment of SMC Frames under Different Column Removal Scenarios

### Abstract

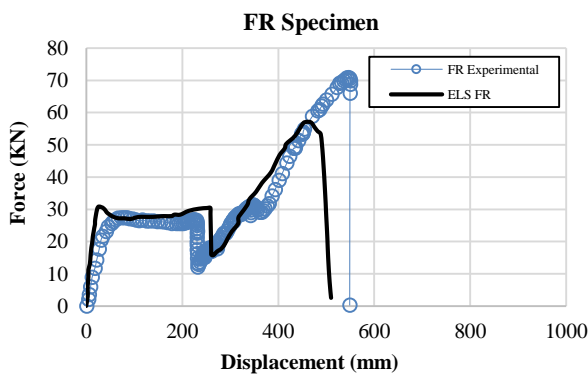
Central deflection versus the applied load is shown in Figures 7 to 9. The analytical model shows acceptable results compared to the experimental results. The specimen encountered the same failure pattern as well as the same crack locations as shown in Figure 10.

Figure 7. Load Versus Displacement for FR

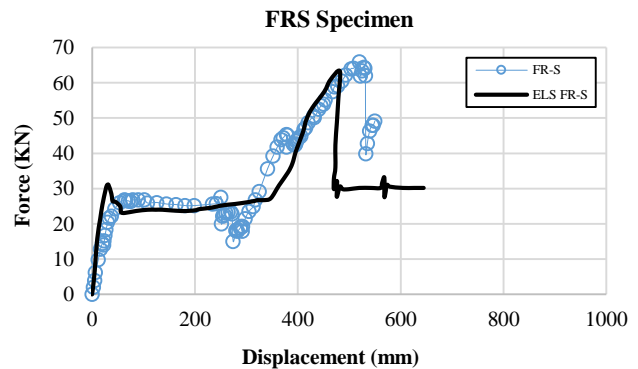
Figure 8. Load Versus Displacement for FR-S

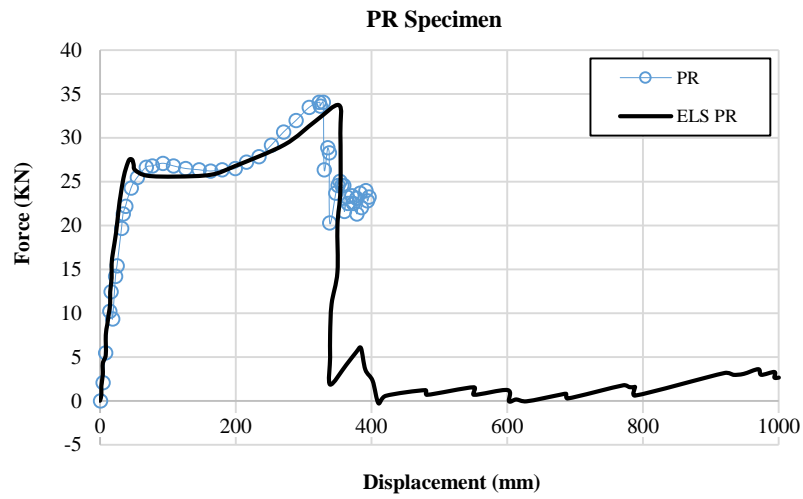
Figure 9. Load Versus Displacement for PR

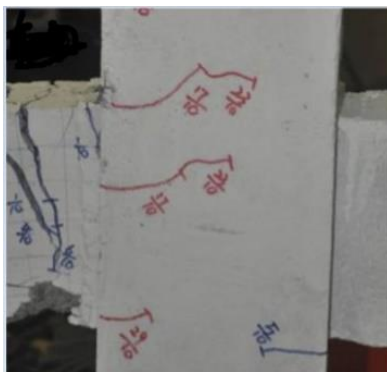
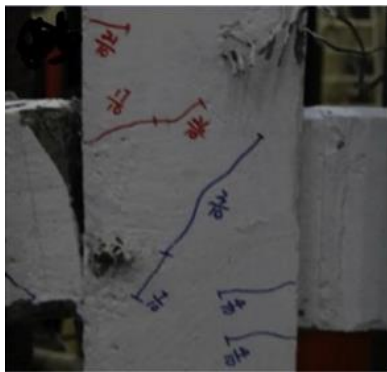
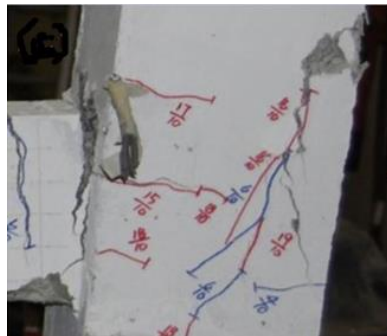
(a) FR Specimen

(a) FR-S Specimen

(c) PR Specimen

Figure 10. Failure in specimens

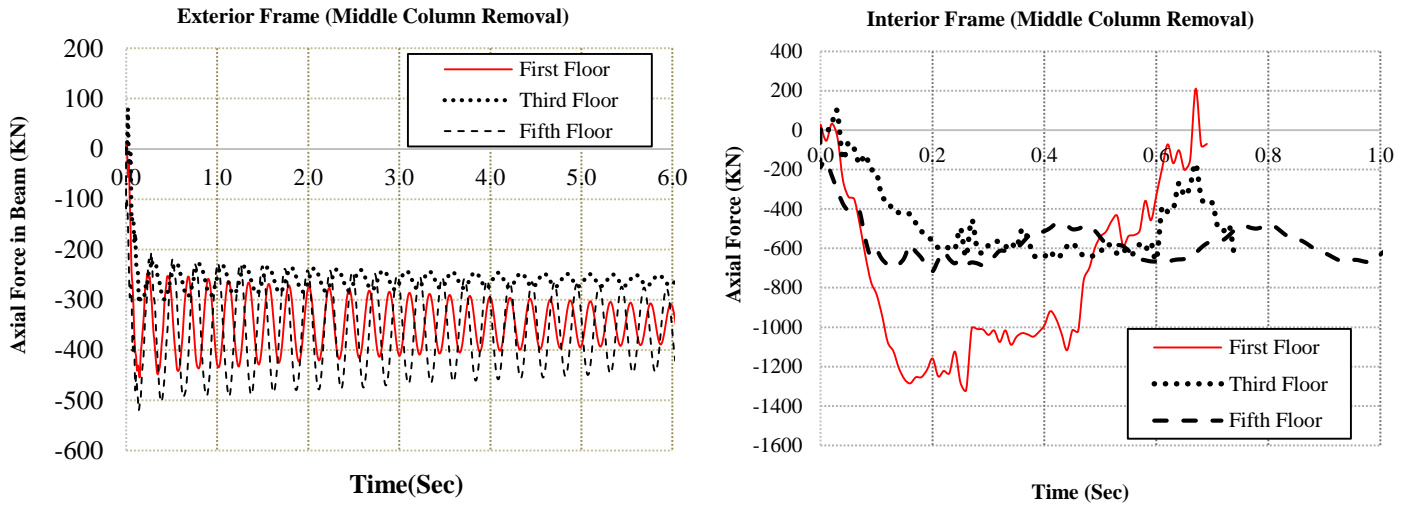
The high compression force took place in the girders at the removed column location due to the compression arching effect. In the Exterior frame, the girder reached maximum compression of 450 KN and then sustained the column loss for the first floor, 290 KN for the third floor and 510 KN for the fifth floor.

In the Interior frame, the girder subjected to high compressive stresses of 1500 KN and then due to the high shear force applied, concrete crushing took place and affected the Concrete strength in compression as shown in Figure 19. For the third floor, maximum compression of 600 KN took place before beam failure, and for the last floor level, the beam sustained the column loss and encountered a compression force of a maximum 630 KN and remained stable.

**Figure 19. Axial force VS Time**

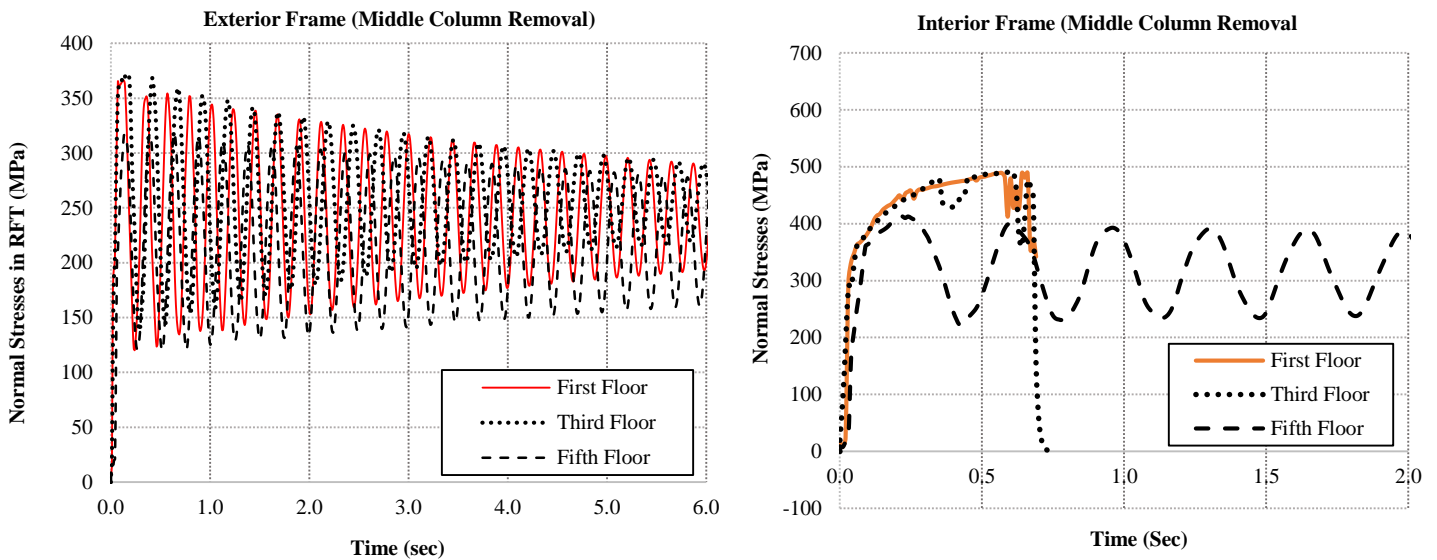
In the Exterior frame, for the three cases, the top reinforcement at the side connection reached its tensile yield stresses of 360 MPa and then stabilized as shown in Figure 21. For the reinforcement at the column removal, the bars encountered compressive stresses due to the change in the structural system from being continuous to a simple beam. Each case faced different compressive stresses as shown in Figure 22. The maximum compressive stresses of 100, 140, and 80 MPa for first, third and fifth-floor column removal took place.

In the Interior frame, at the side connection, for the first floor and the third floor, the reinforcement resisted high tensile stresses till ultimate, then shear failure took place before the rupturing of reinforcement at time 0.66 seconds. For the fifth floor, tensile stresses reached 400 MPa and then stabilized.

Figure 21. Normal Stresses in Top Side RFT versus Time at sides

At the column removal connection, the reinforcement for the first and third floors encountered maximum compressive stresses of 420 and 360 MPa before the beam shear failure. For the fifth floor, the top reinforcement reached 200 MPa maximum compressive stresses and then stabilized as shown in Figures 21 and 22 respectively.

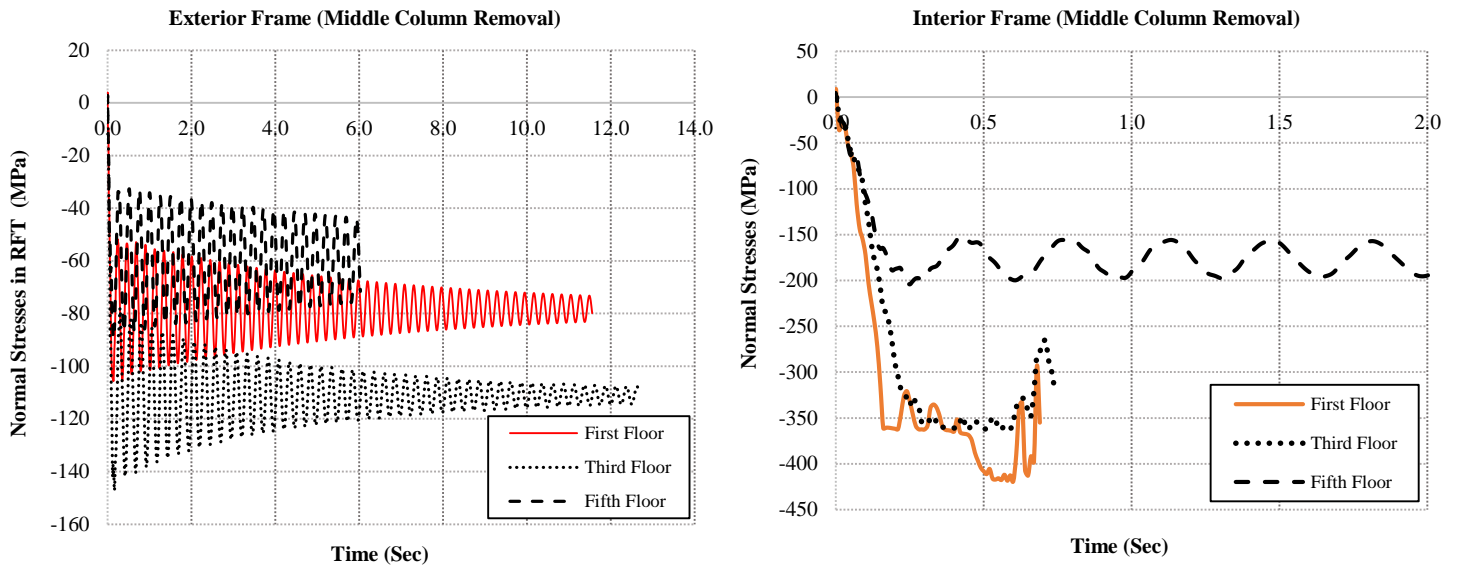
Figure 22. Normal Stresses in Top Side RFT versus Time at column removal

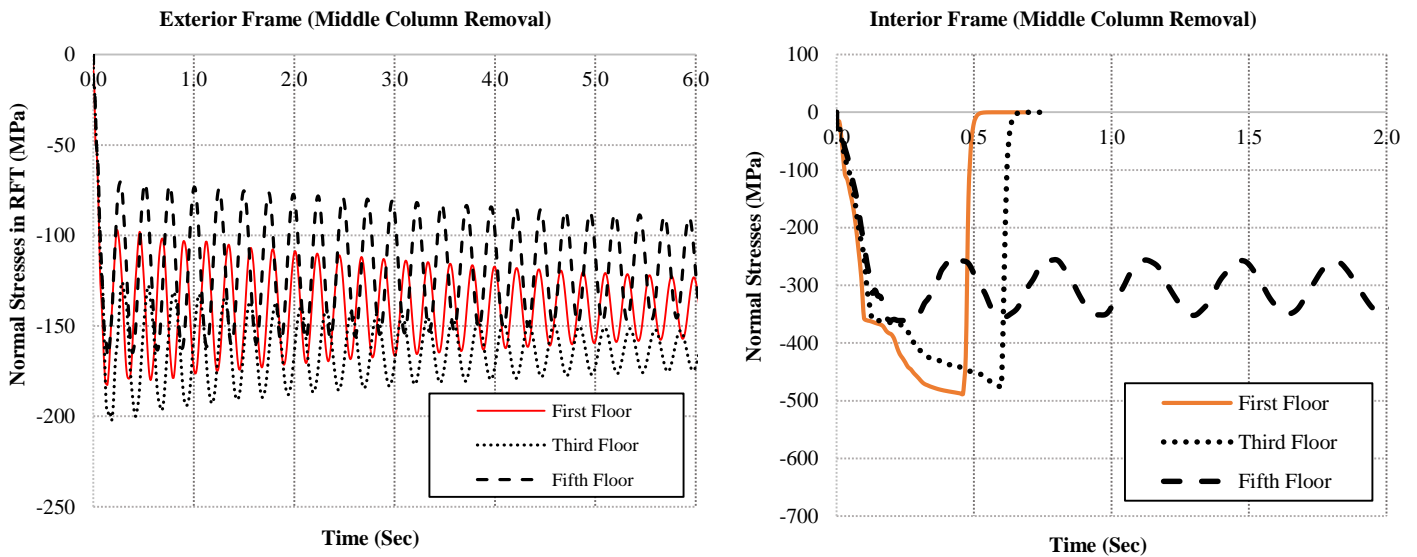
The normal stresses in bottom reinforcement for both Exterior and Interior frames are calculated as shown in Figures 23 and 24. For the bottom reinforcement at the sides, the reinforcement encountered compressive stresses due to the applied negative bending moment on the connection. For the Exterior frame, the maximum stresses of 200 MPa took place for the third floor and then stabilized.

For the Interior frame, the bottom reinforcement failed for the first and third cases. The first floor failed earlier after reaching maximum stresses of 498 MPa. The fifth floor reached 360 MPa and then stabilized.

Figure 23. Normal Stresses in bottom RFT versus Time at sides

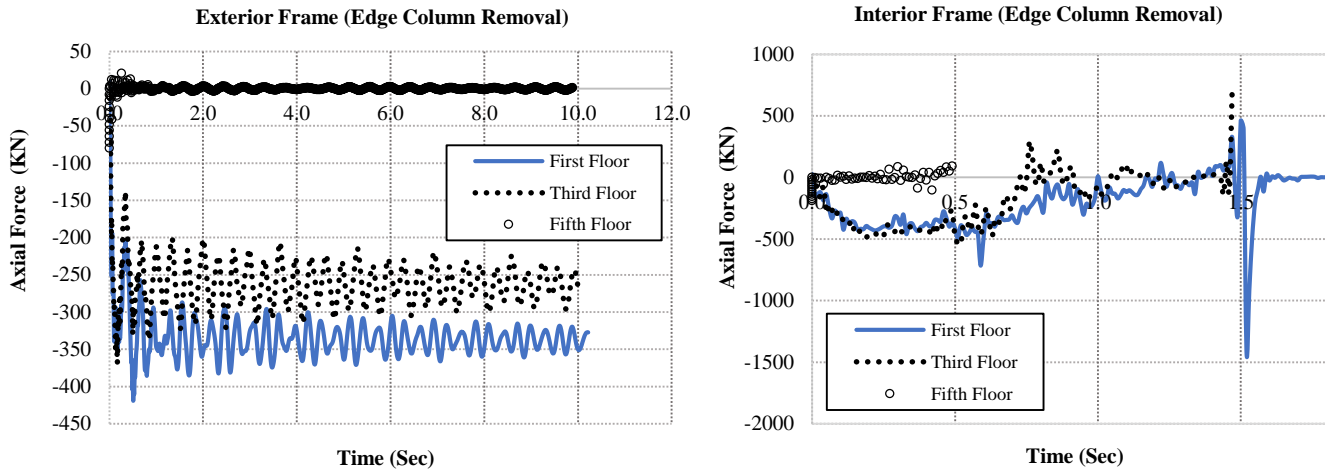
In the Exterior frame, the girder reached maximum compression of 400 KN and then sustained the column loss for the first floor, 350 KN for the third floor and zero force for the fifth floor.

In the Interior frame, the girder subjected to high compressive stresses of 500 KN for both first and third-floor cases and then shear failure took place as shown in Figure 28. For the last floor, no compression arching phenomenon took place, and the beam failed due to high negative bending moments resulted from load redistribution due to column loss.

Figure 28. Axial force VS Time
